**ecology and environment, inc.**

July 27, 1998

Ref. No.: T190698-006  
TDD No.: 099804-001  
PAN No.: 0300PPSF-XX

Subject: **Pomona Plating, Site Assessment, Interim Report #2 and Final, Pomona, California****Introduction**

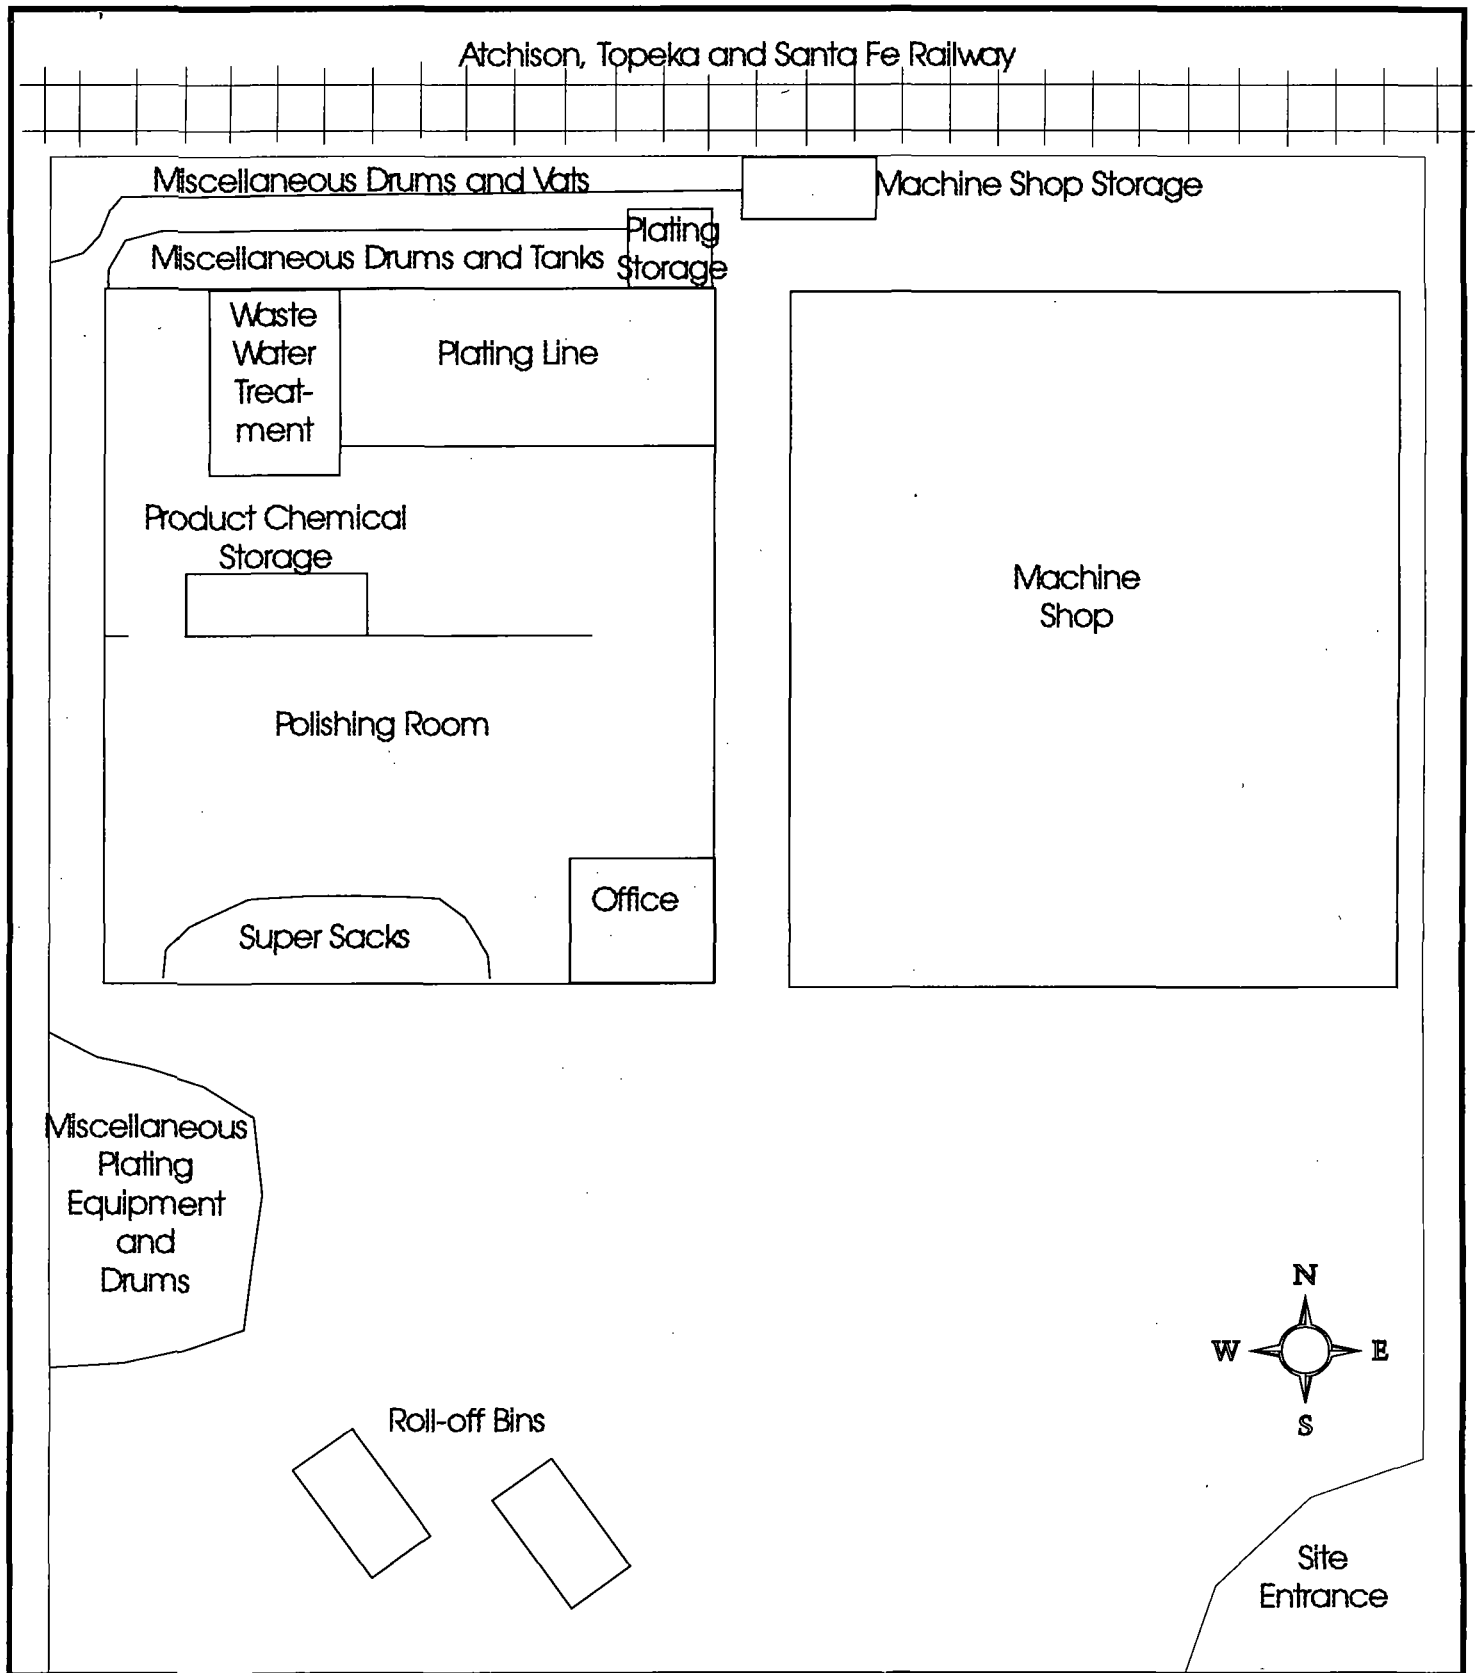
Figure 1:  
Site Diagram  
Pomona Plating  
Pomona, California

The facility consists of a single approximate 10,000 square foot structure. The building is equally divided between a polishing room /office area and main plating line/wastewater treatment and chemical storage area. The property also contains an approximate 2,500 square foot back lot where plating chemicals and waste are stored. Immediately north of the back lot area is a rail-line and right of way. A large parking lot, serving both Pomona Plating and an adjacent metal machine shop, is located south of the building. Miscellaneous plating debris, various plastic and metal 55-gallon drums, partially burned plastic plating vats, and two covered roll-off bins filled with contaminated debris are located at the western edge of the parking lot (see Attachment A, Figure 1: Site Diagram).

The western edge of the parking lot area (see Figure 1) contained miscellaneous scattered debris, fire damaged process equipment and empty vats, metal parts and empty containers. A total of nine full 55-gallon drums of wastewater treatment system additives and cleaning

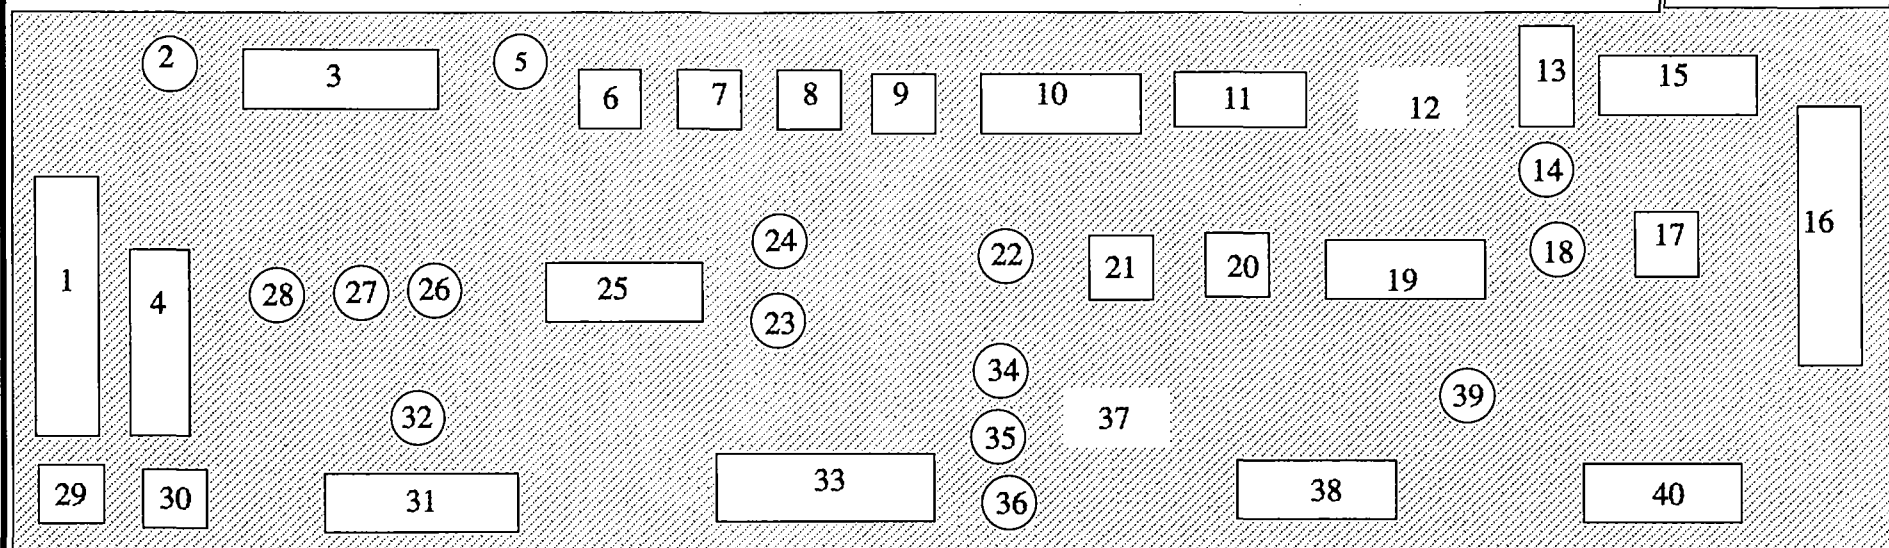
Figure 2:  
Plating Line Diagram  
Pomona Plating  
Pomona, California

Each of the 41 vats and drums comprising the plating line were measured and the capacity and content volumes were estimated by START. The START numbered each vat and drum with spray paint and prepared an updated schematic of the plating line (see Attachment A, Figure 2: Plating Line Diagram). Access to each vat and drum is from a raised wooden walkway constructed over the bermed concrete floor. Vat and tank descriptions were provided by either Mr. Sanchez or Mr. White.

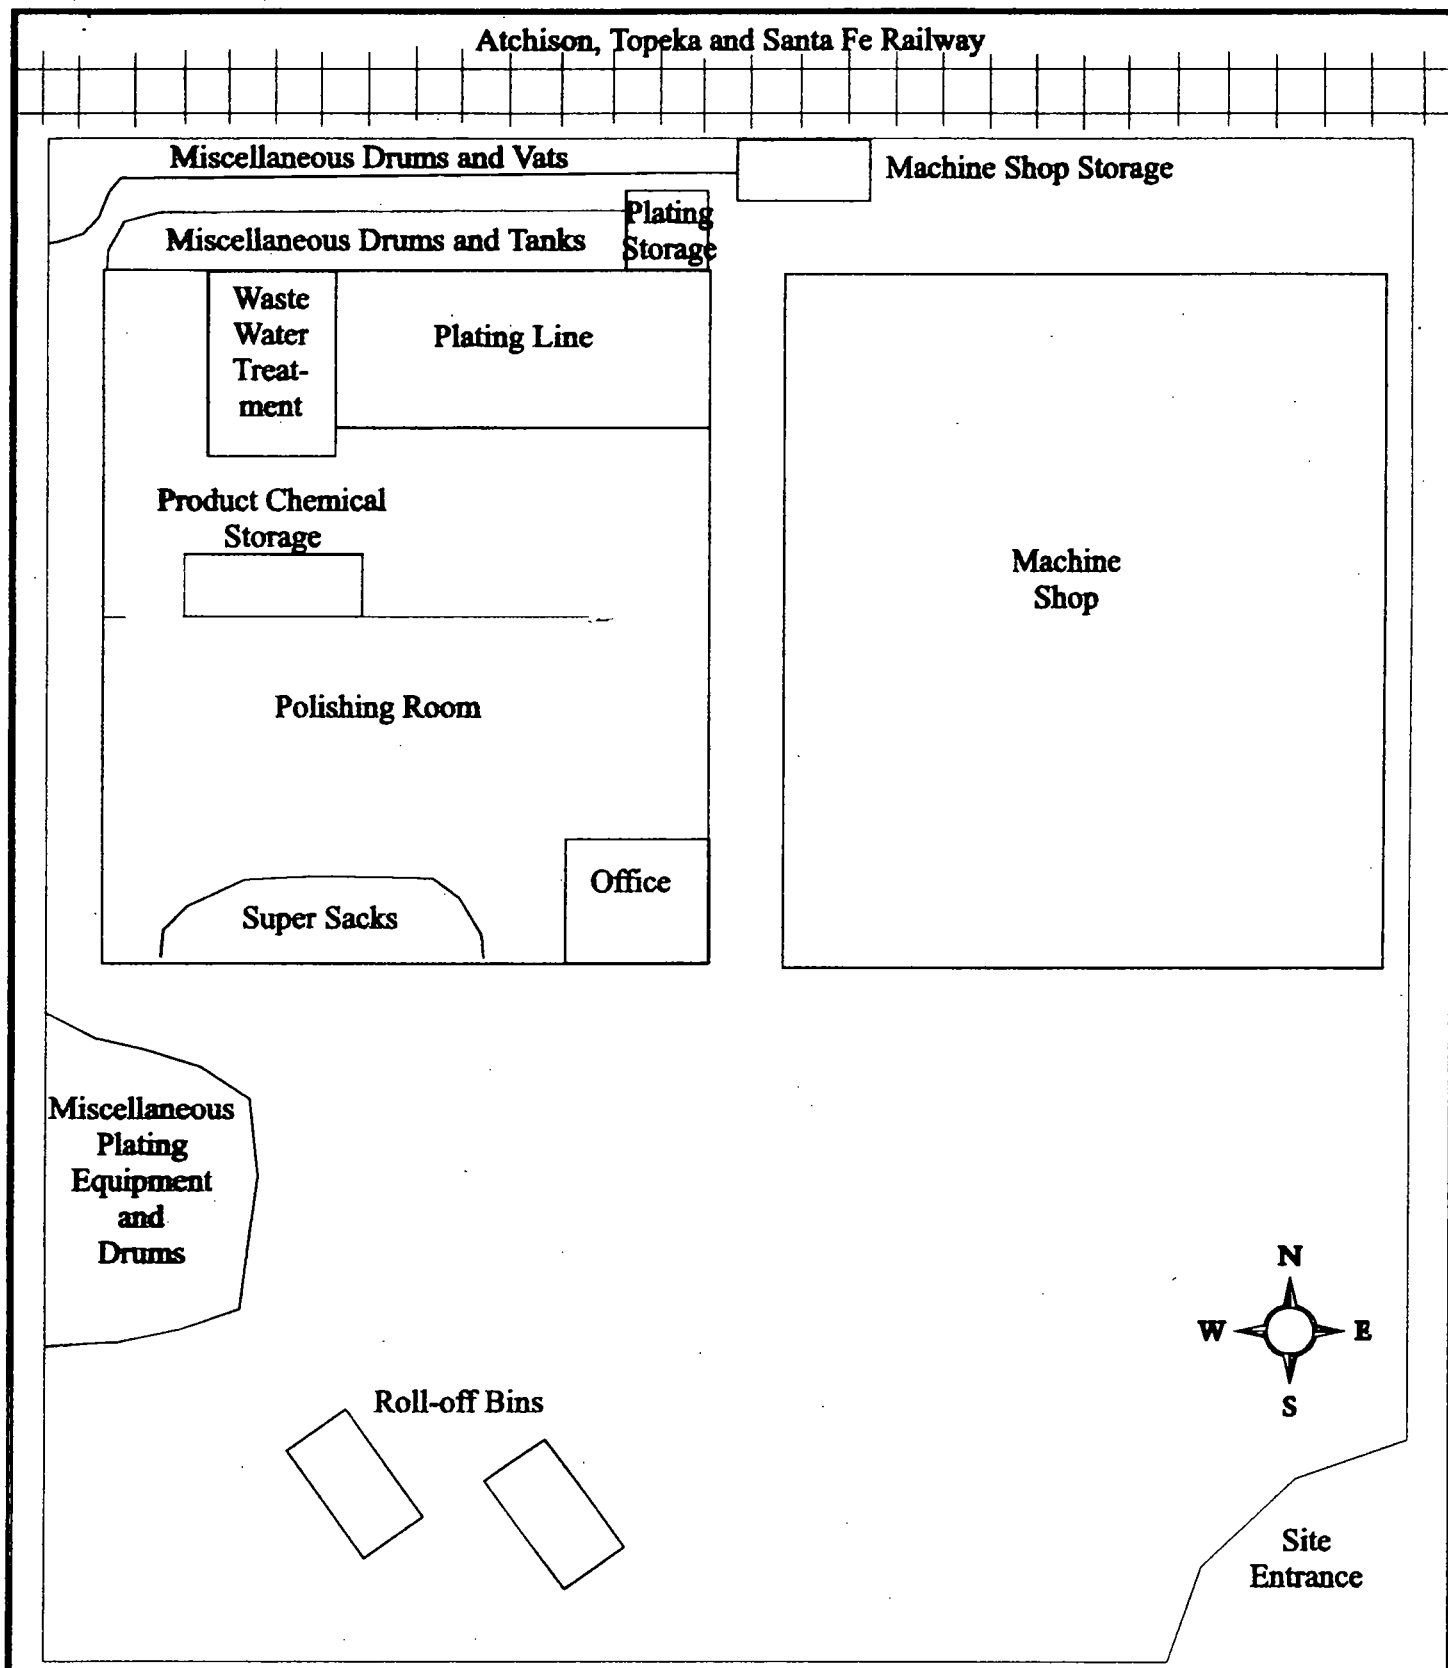
Figure 2:  
Site Diagram  
Pomona Plating  
Pomona, California

Pomona Plating consists of a single approximate 10,000 square foot structure. The building is equally divided between a polishing room /office area and main plating line/wastewater treatment and chemical storage area. A large parking lot is located south of the facility which also serves the metal machine shop. Facility access is accomplished through a door located on the south facing wall of the warehouse, doorways on the east facing wall of the warehouse, and several roll-up bay doors on the north, south, and east sides of the building. Access into the facility can also be made through an unsecured hole on the north facing wall of the warehouse. The property also contains an approximate 2500 square foot back lot area where plating chemicals and waste are stored. Immediately north of this back lot area fence line is a rail-line and right of way. (see Figure 2, Site Layout).

Within the parking lot is miscellaneous plating debris, various plastic and metal fifty-five gallon drums, partially burned plastic plating vats, and 2 covered roll-off bins filled with what is believed to be plating cake material. Also within the parking lot are the cars which belong to the employees
